**Report on the Explosion, Fire, and
Oil Spill Resulting in One Fatality
and Injury on September 21, 1978,
at Well 6 of Cavern 6 at the West Hackberry,
Louisiana, Oil Storage Site of the Strategic
Petroleum Reserve**

November 1978

U.S. Department of Energy
Washington, D.C. 20545

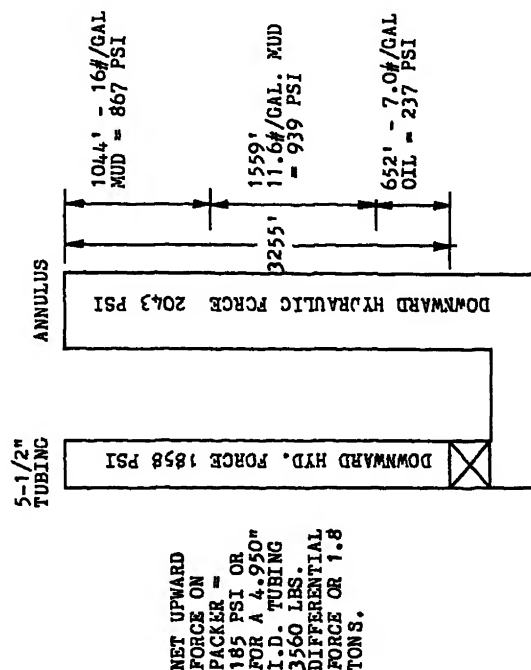
Figure 28. Initial Hydraulic Forces on the Packer

there was a 185-psi differential across the packer or a total differential force of 3,560 pounds. When 14 joints of tubing had been pulled out of the hole and the packer had been moved up the hole with the bottom of the pipe to 2,820 feet, the hydraulic forces were as shown in Figure 29. The U-tube representation of the forces within the hold at that point indicate that there was a 367-psi differential or a 7,063-pound total differential force being exerted upward on the packer.

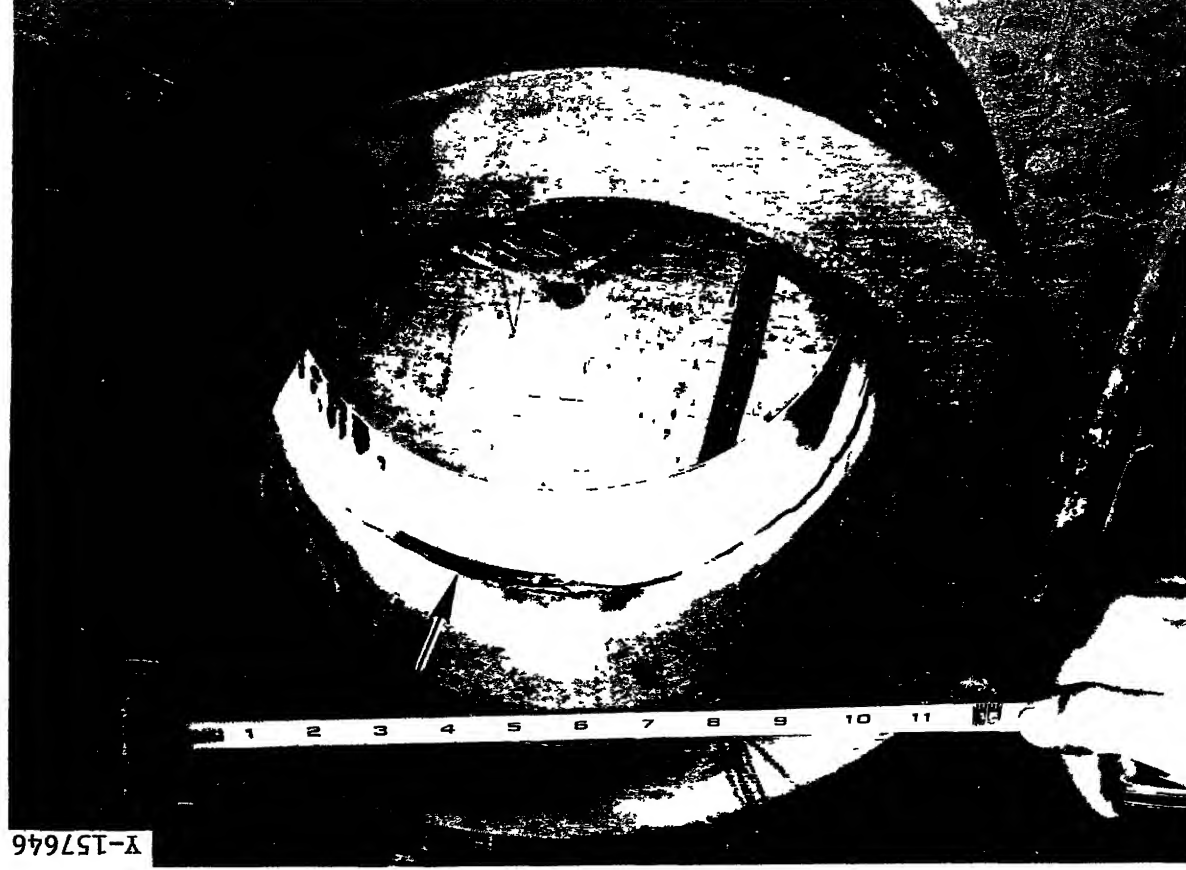
Fig. 5. Dye-penetrant inspection of internal bore weld reveals gross cracking and through-weld leak.

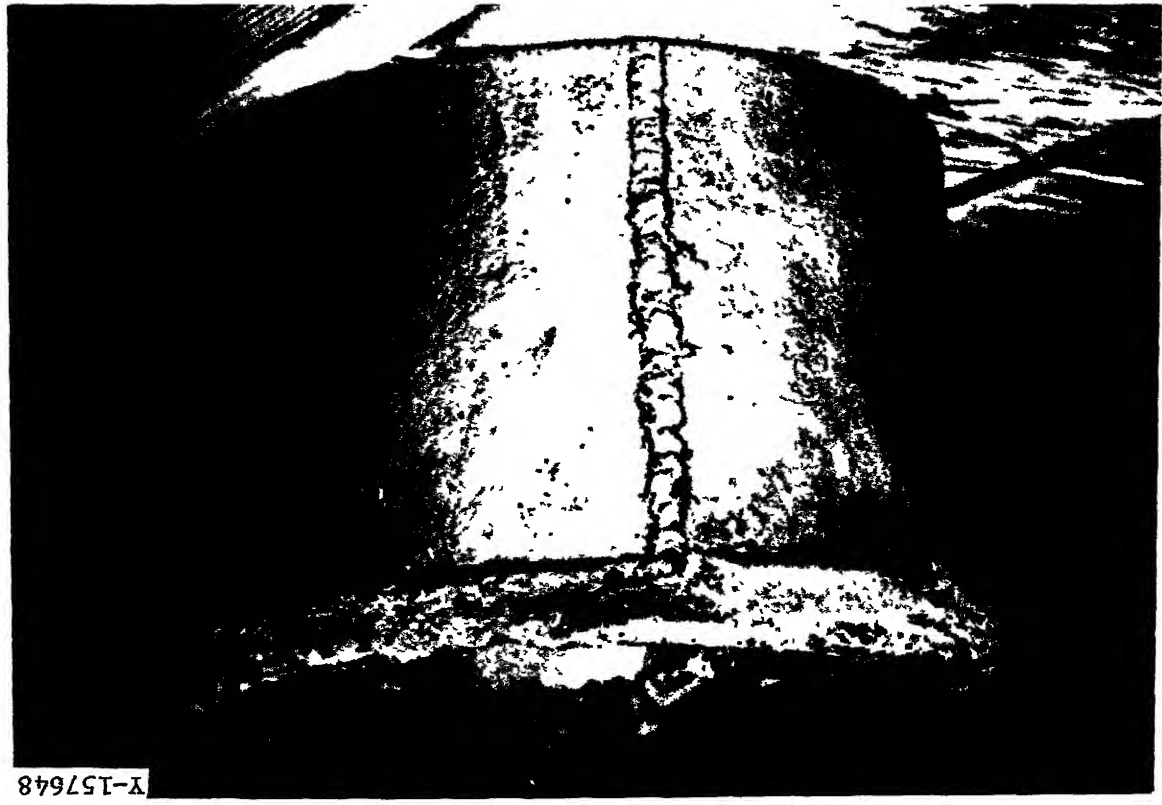
Fig. 10. Exterior of Outer Casing Showing Longitudinal Weld. Dye-penetrant inspection revealed a through-weld leak. It should be noted that the clamp and elastomer gasket were located over this region at the time of the incident.

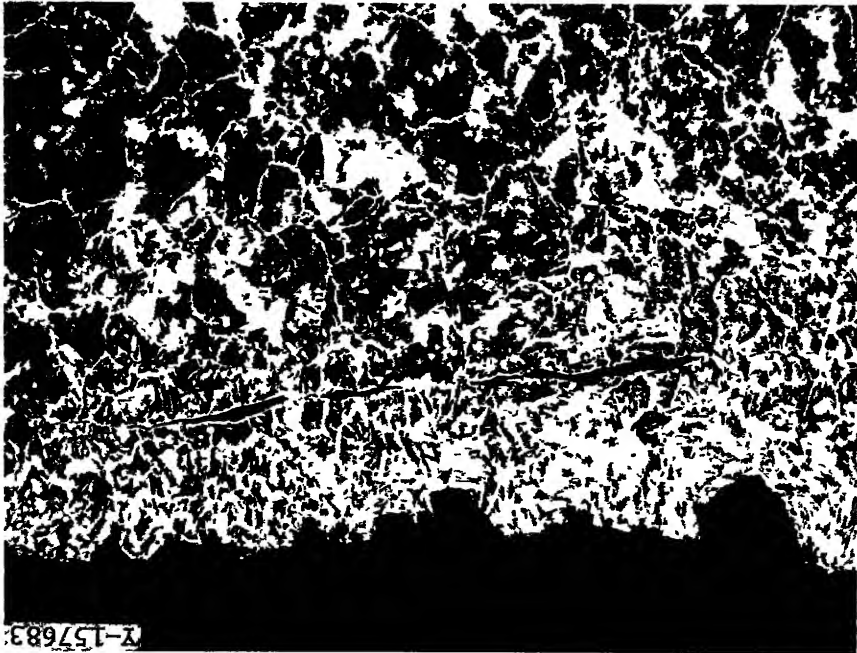
Fig. 14. Photomicrograph of Fracture Edge Showing Small Fissure Slightly Below the Plane of Fracture.

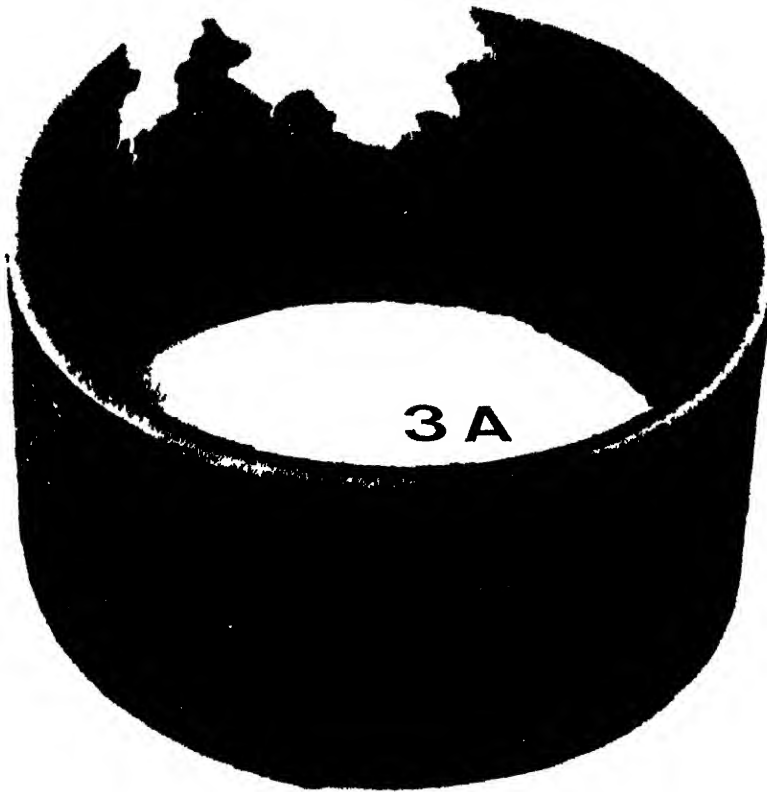
Fig. 23. Pipe 3 Showing Hole in More Detail.

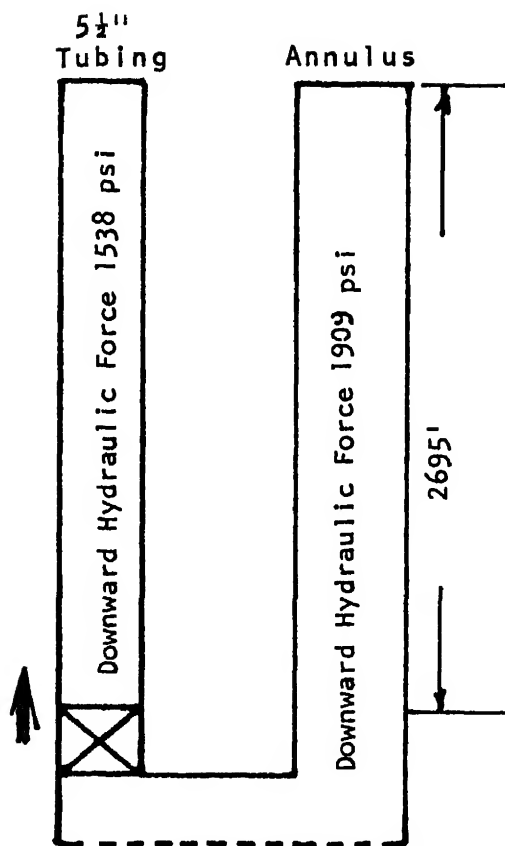
Figure 11.

Well 6 As A "U" Tube
HYDRAULIC FORCES WHEN THE PACKER FAILED

Net Upward
Force on Packer
371 psi
or for a
5" I.D. Tubing
7270 Pounds
or
3.6 Tons
